INSPECTION REPORT

Inspection Date	05/25/2016	Client Name	
Inspection Number	12-13373	Client Phone	
Inspection Address (City, State Zip)		Client Email	
Inspected By	Kris Skirrow, Florida Home Inspector HI179, Sean Skirrow, Florida Home Inspector HI182 Chris Costa, Florida Home Inspector HI8937

The Minorca Condominium, unit #XXXX. The condominium has 4 bedrooms and 3 baths with 2610 square feet of heated and air conditioned living area. The condominium is in good condition with deficiencies highlighted in this report.

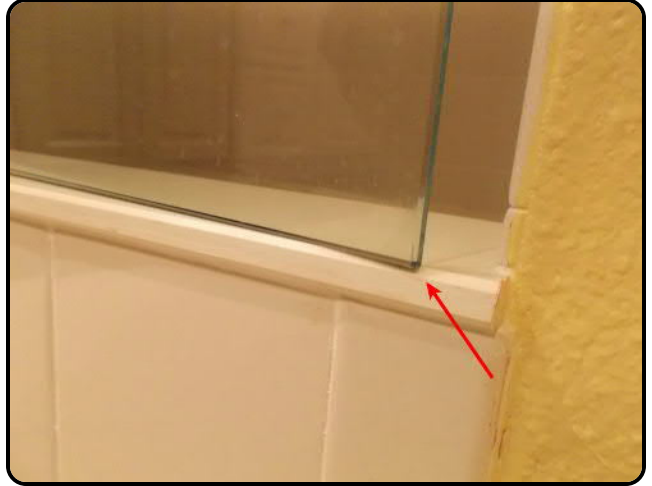
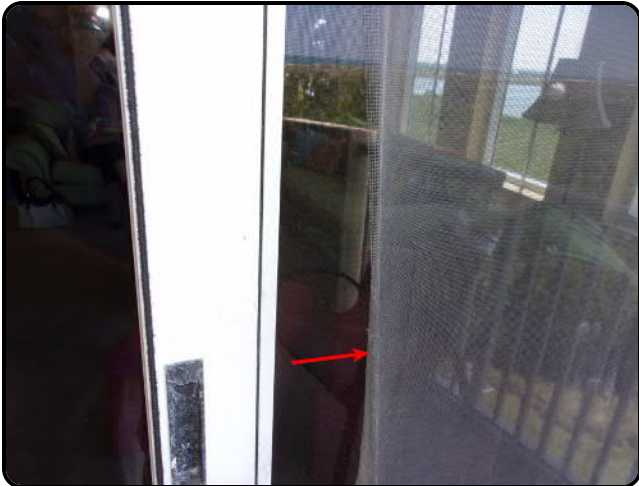
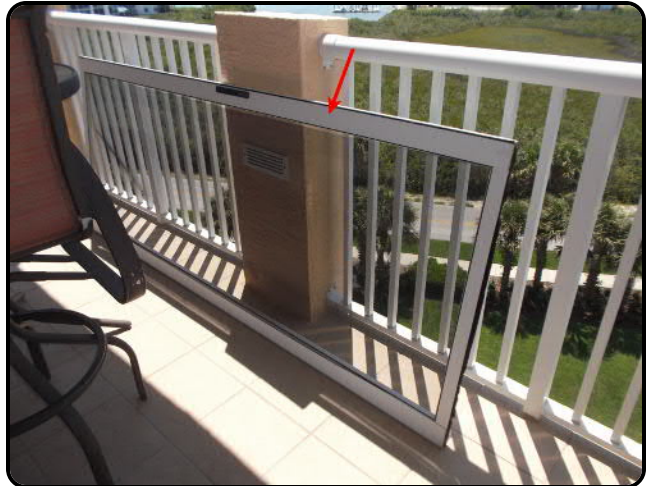
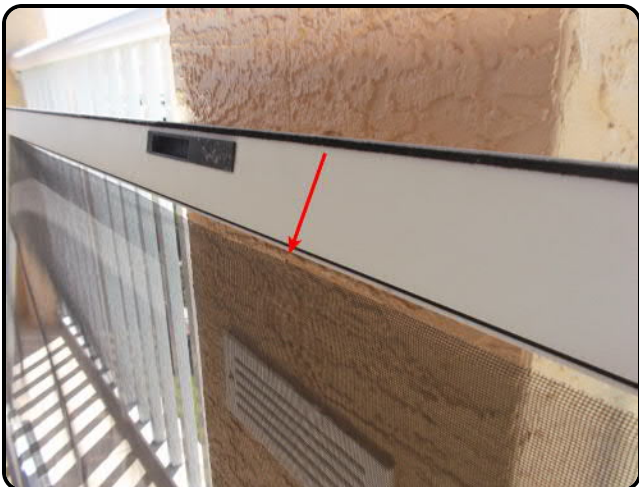
Structure And Components Pictures (page 10 - 10)

1. The great room patio sliding door will not remained locked. "Lock Repair Indicated"
2. The master bathroom shower glass door binds on the shower step. "Repair Indicated"

1. There are torn screens in the great room patio screen door. "Screen Replacement Suggested"
2. The kitchen patio sliding screen door was not installed at the time of the inspection and is torn. "Repair and Installation Suggested"

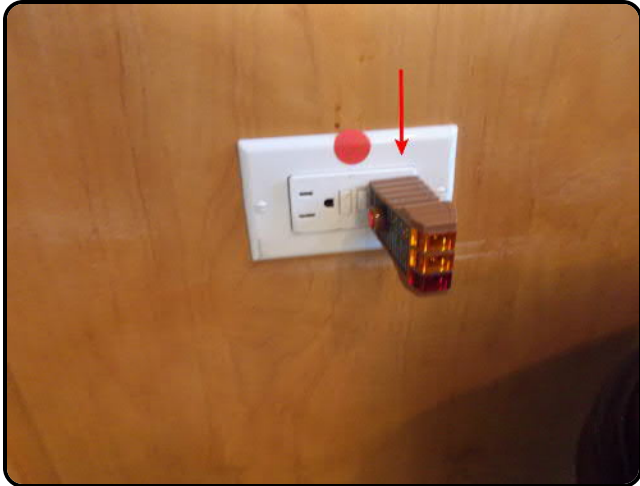
Electrical System Pictures (page 13 - 13)

1. The kitchen island GFCI outlet is inoperable. This outlet has been marked with a sticker by the inspector. "GFCI Outlet Replacement Indicated"

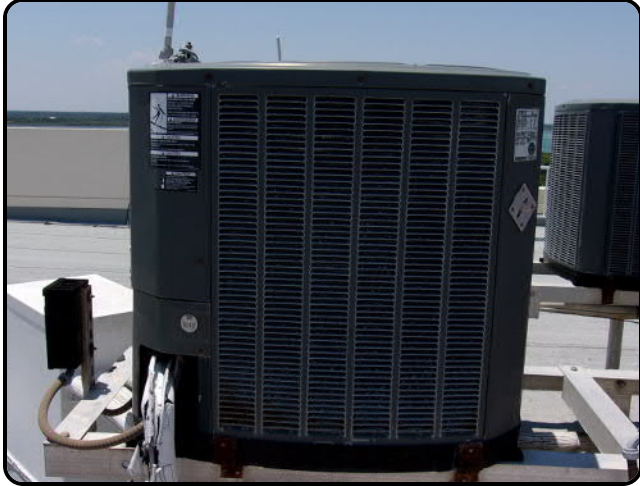
Air/Heat Conditioning System Pictures (page 15 - 15)

Unit	Estimated Age	Manufacturer	Cooling Capacity	Measured Temperatures Air	Measured Temperatures Heat
Main	Air Handler: 2005 Condensing Unit:2005	Trane	5 ton	Supply: 56 Return:74	Supply: 98 Return:74
